National Dam Inspection Program.

Bear Creek Dam (PA-00607),
Schuylkill River Basin, Bear Creek,
Carbon County, Pennsylvania.
Phase I Inspection Report.

BEAR CREEK DAM
CARBON COUNTY, PENNSYLVANIA
NATIONAL I.D. NO. PA 00607

PHASE I INSPECTION REPORT NATIONAL DAM INSPECTION PROGRAM

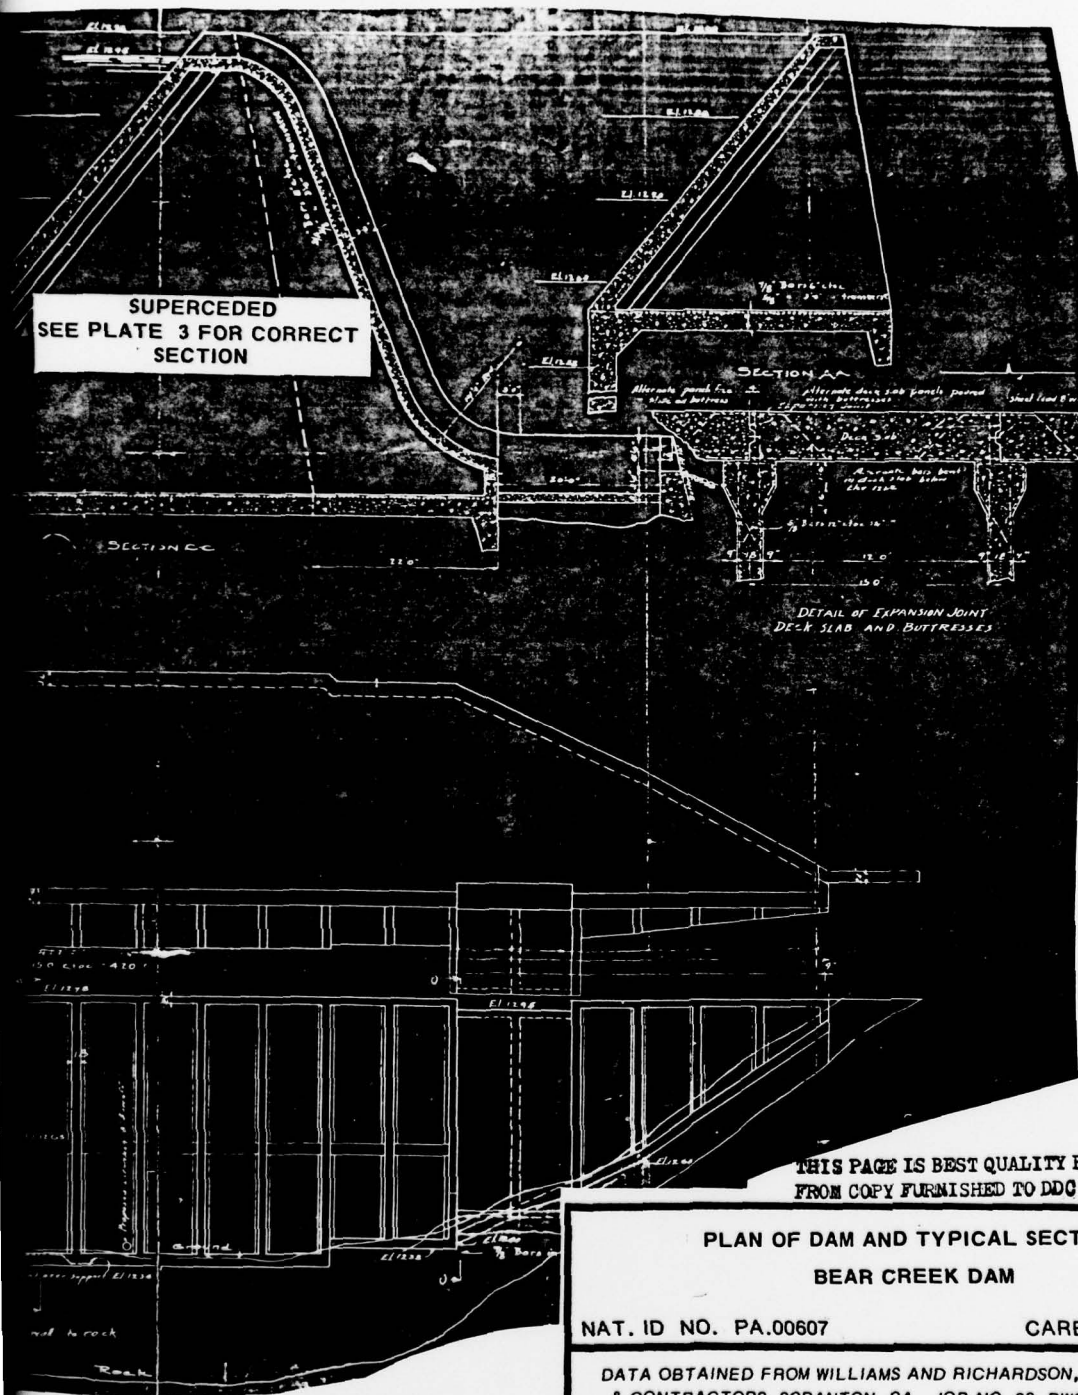
PLAN OF DAM AND TYPICAL SECTIONS BEAR CREEK DAM		
NAT. ID NO. PA.00607		CARBON COUNTY
DATA OBTAINED FROM WILLIAMS AND RICHARDSON, ENGINEERS & CONTRACTORS, SCRANTON, PA. JOB NO. 38, DWG. NO. 36		
	2	PLATE 2

As shown in Appendix E, Plate 2, the dam is a hollow concrete structure with an upstream slab inclined at a batter of 10 H:12V. The downstream batter is 2H:12V. The dam contains 29 buttress walls forming 28 bays supported on a concrete slab. Each bay is 15 feet on center for a total length of 420 feet. Wing walls extend beyond the buttress walls and extend the length of the dam to approximately 480 feet. The twenty-third and twenty-fourth bays contain the spillway portion which has a crest elevation of 1295.0. The parapet walls extend to elevation 1298.

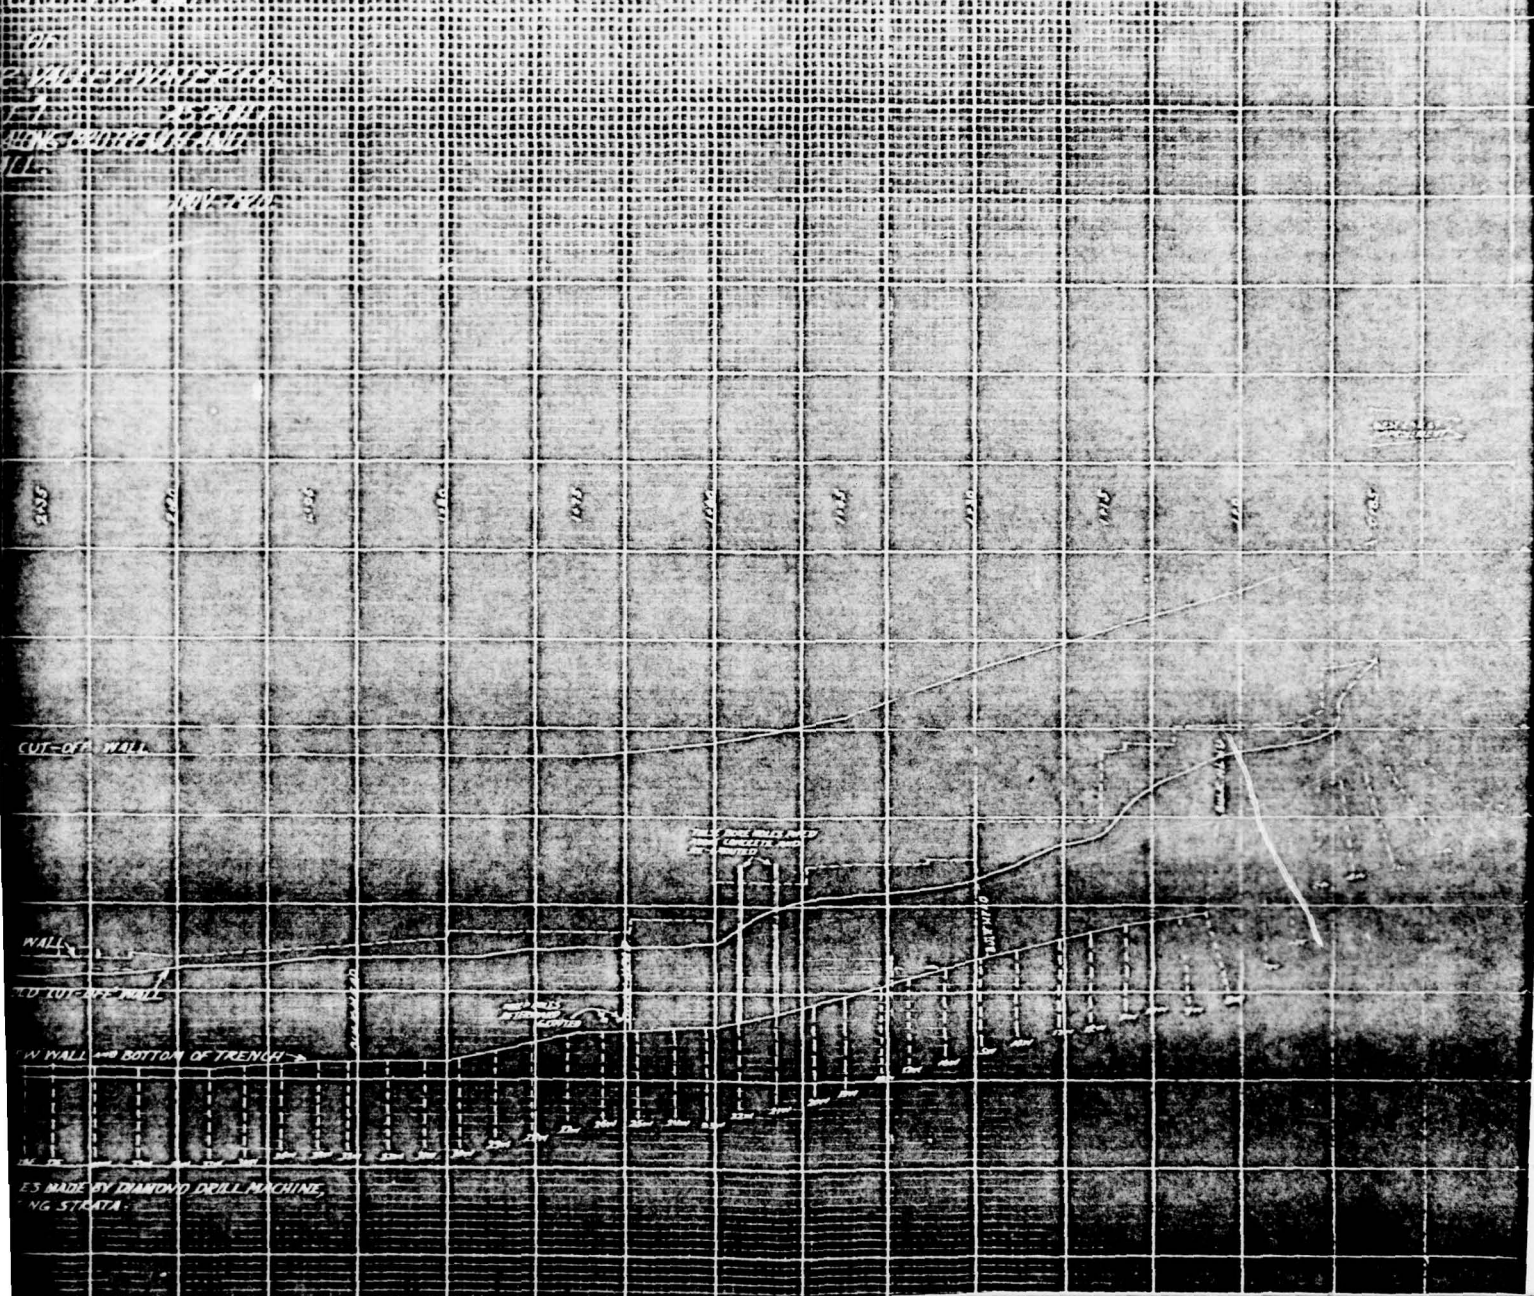
PROFILE OF DAM SHOWING EXTENT
OF 1920 IMPROVEMENTS
BEAR CREEK DAM

*in the old Cut-off Wall which was between 1910 and 1920
a mixture of clay from flume and selected material
on side of the dam south of the old Clay breast*
